Manges Cabin Roof Replacement  
Summer 2007  
Greg Dodson, Hank McCurdy

**Project Objective:** to remove all deteriorated roofing material and replace in-kind with new material.

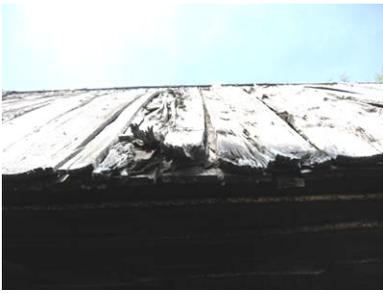
**Project details:** WCHP first set up scaffolding on the south side of the cabin. On that side, WCHP crew removed the top layer of boards and a layer of 30 lb felt.

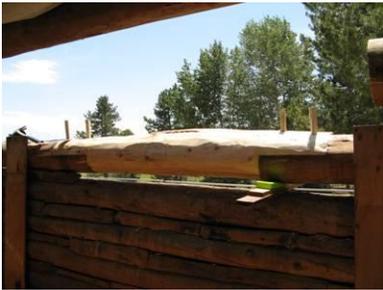
Once the top layer of felt was removed the crew noticed water damage to the bottom layer of boards. The WCHP crew at first only removed damaged boards from the bottom layer, rather than removing all boards as they had done on the top layer. While removing the damaged bottom layer of boards, the crew noticed that there was also deterioration and rot on some of the purlins. Because of the poor condition of the purlins, the crew removed all the bottom boards so that they could

replace two entire purlins that had deteriorated. In addition to replacing two entire purlins, the crew also completed a partial replacement on the lowest purlin.

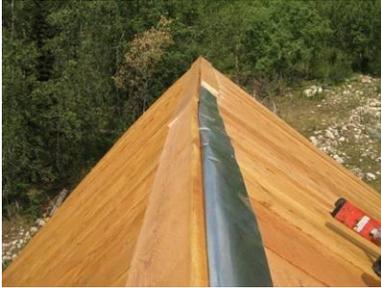
The WCHP crew then began reroofing the north side of the cabin. The crew moved the scaffolding to the north side and removed only the top layer of boards and the felt. After removing these layers, the crew noticed that the lower layer of boards was in good condition and that none required replacement. Because the lower layer of boards was in such good condition and the purlins appeared to be in good condition from inside the cabin, the crew felt that the purlins also did not require replacement or repair. Before applying the new felt, the crew refastened with nails some of the lower boards which were loose. Like on the south side of the cabin, the crew used two layers of felt for added protection. Following the reapplication of the felt, the crew

replaced the top layer of boards with new rough-cut pine boards. As a last step, the crew trimmed all boards (top and bottom layers) by two inches to straighten the bottom edge of the roof and remove minor rot from the bottom layer. The WCHP crew then treated the cut ends with wood preservative.
